# National Naval Medical Center Master Plan Update 2008

Appendix - Existing Building Assessments

Bethesda, Maryland

8 AUGUST 2008

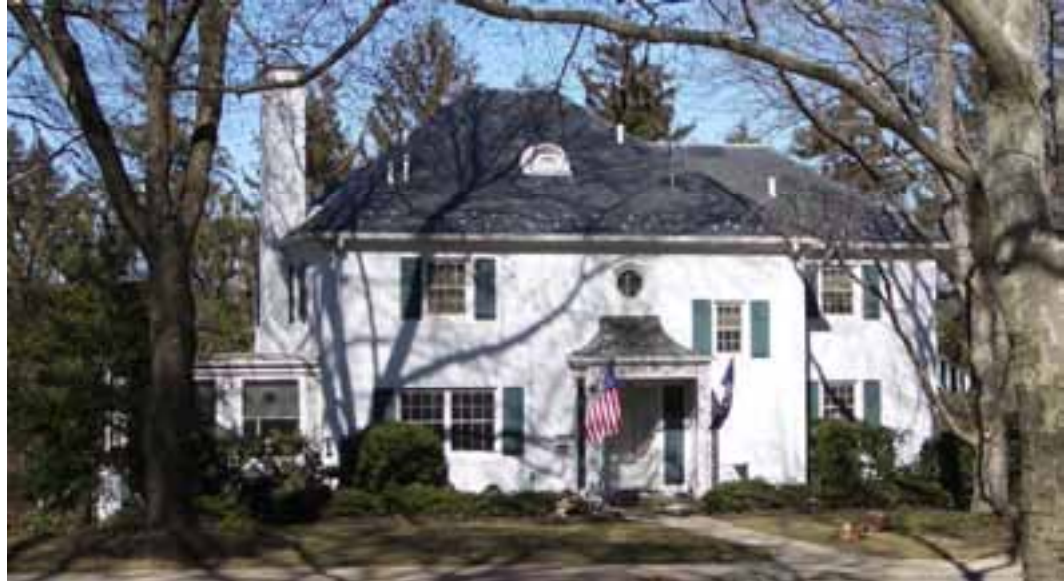
## Building 34, 35, 36, 37, 38 – Flag Housing

**Interior B (Good)** – The interior condition of Buildings 34, 35, 36, 37, and 38 is unknown. No review of these residences was done.

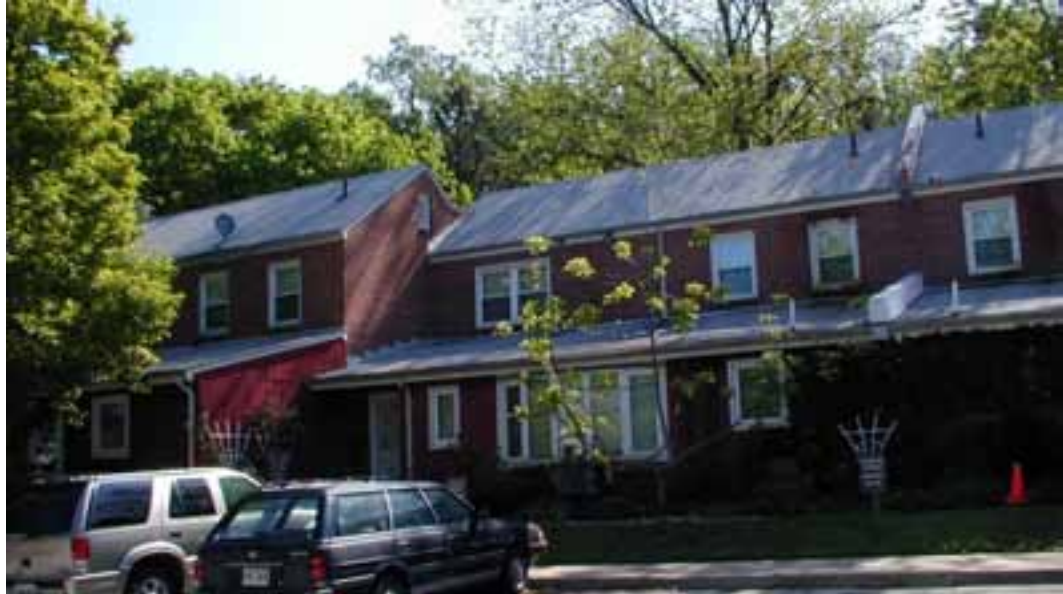
## Building 39, Bldg 40, Bldg 41 – Officers Housing

**Interior C (Fair)** – The interior condition of Buildings 39, 40, and 41 are unknown. No interior review of these residences was done.

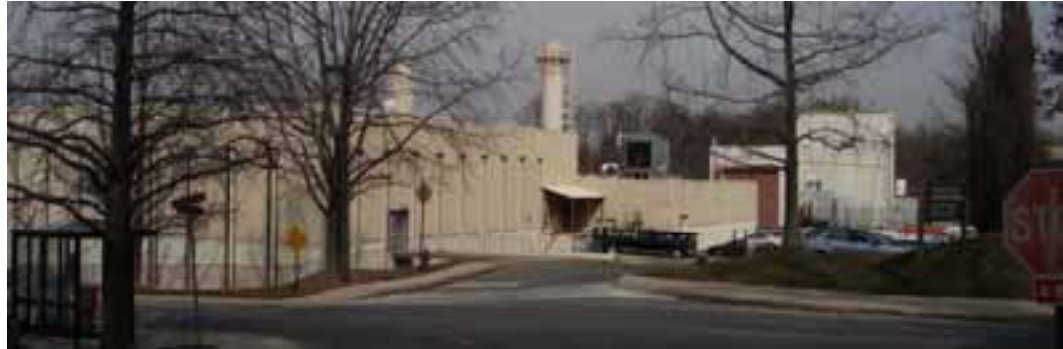
## Building 42-48 – AFRR

**Interior C (Fair)** – Due to its age, the interior of Buildings 42-48 are in fair condition. Over the years the buildings have been expanded which has led to an overall organization that is confusing and difficult to comprehend the buildings means of egress. The finishes have received normal wear and tear and are worn therefore recommended to be renovated.

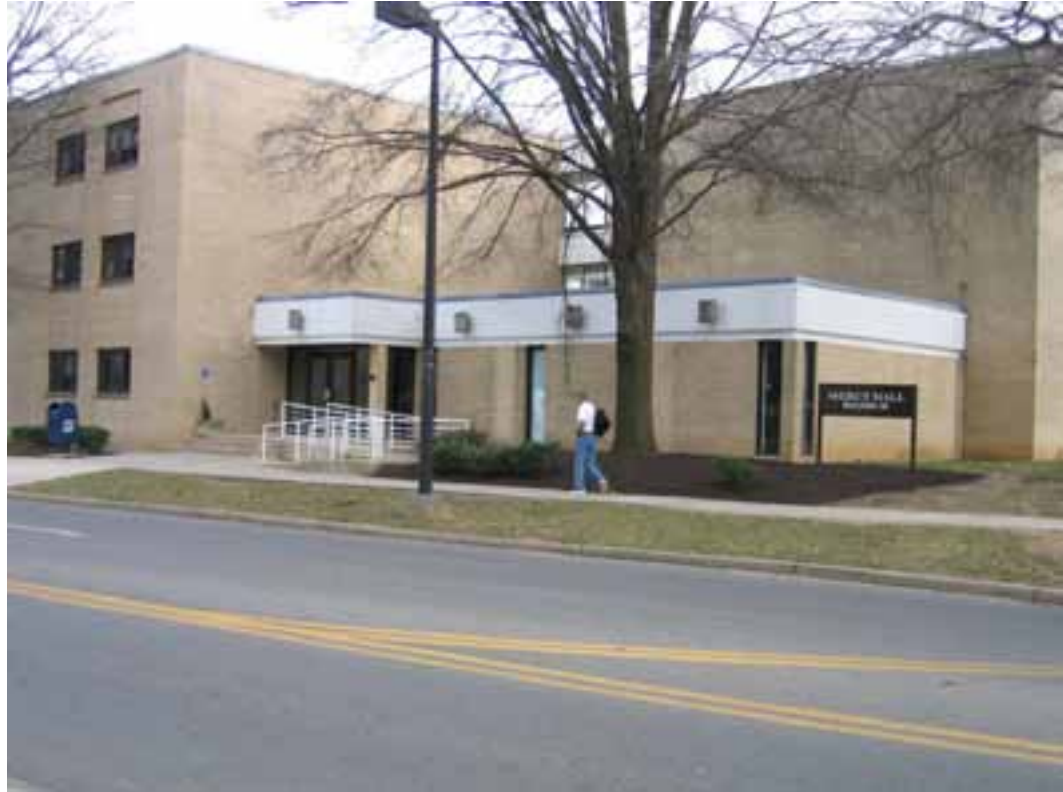
## Building 50 – Medical Hold and Bachelors Quarters

**Interior C (Fair)** – The interior of Building 50 is considered to only be in fair condition because the finishes are old and could be refurbished.

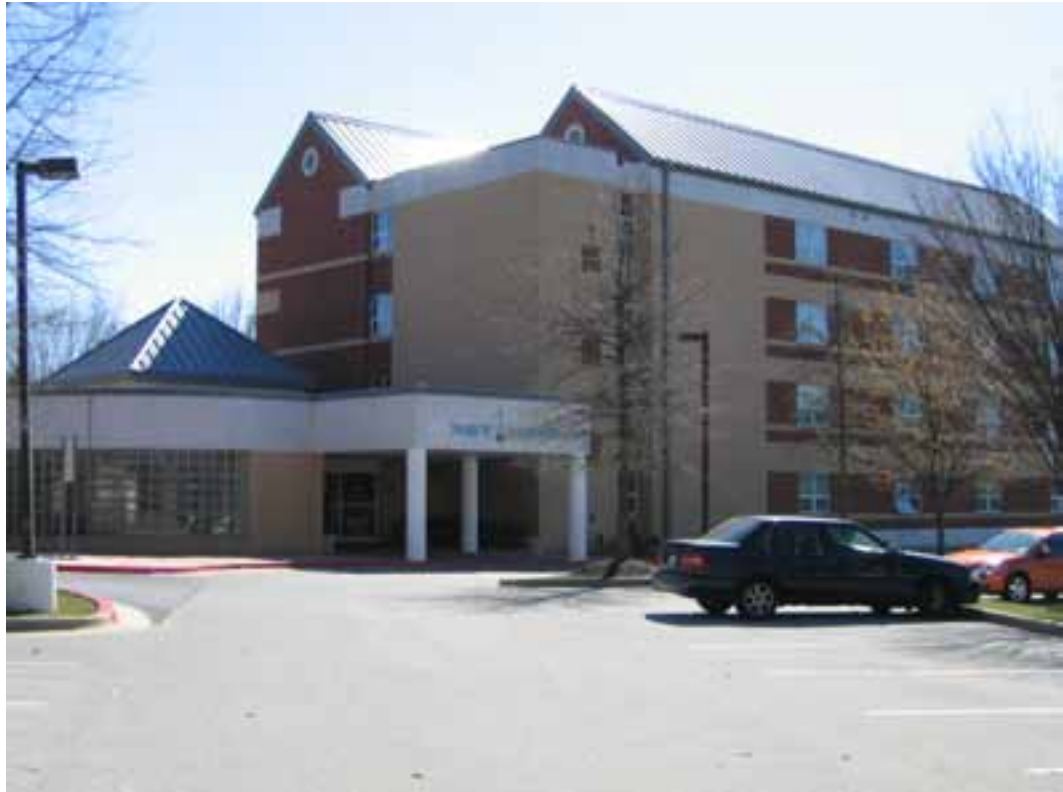
## Building 52 – Navy Lodge

**Interior B (Good)** – The interior of Building 52 is in good condition. Finishes visually appear to be in good condition and well maintained.

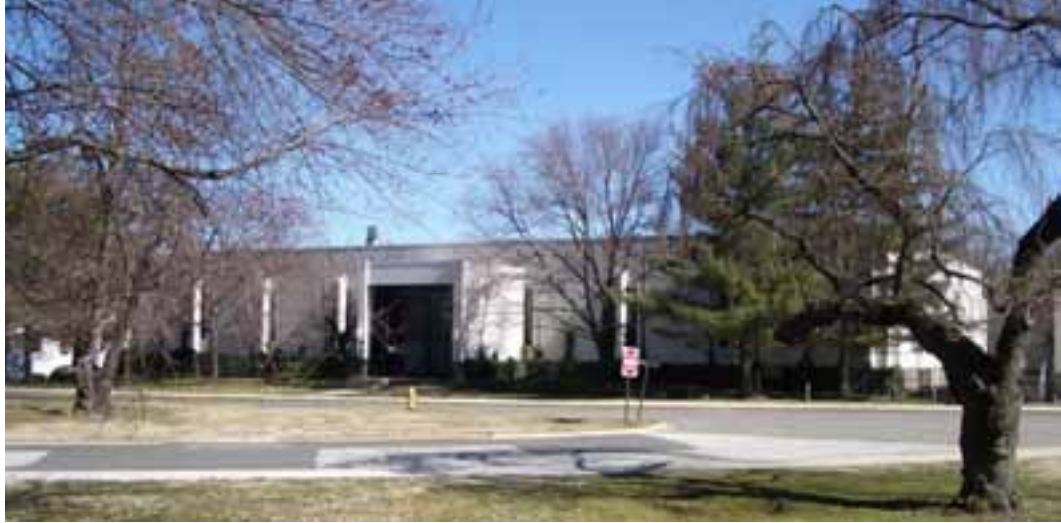
## Building 53 – Environmental Health Effects Lab

**Interior C (Fair)** – The interior of Building 53 is in fair condition because most of the partitions and finishes are old with the exception of relatively new ceiling and floor finishes.

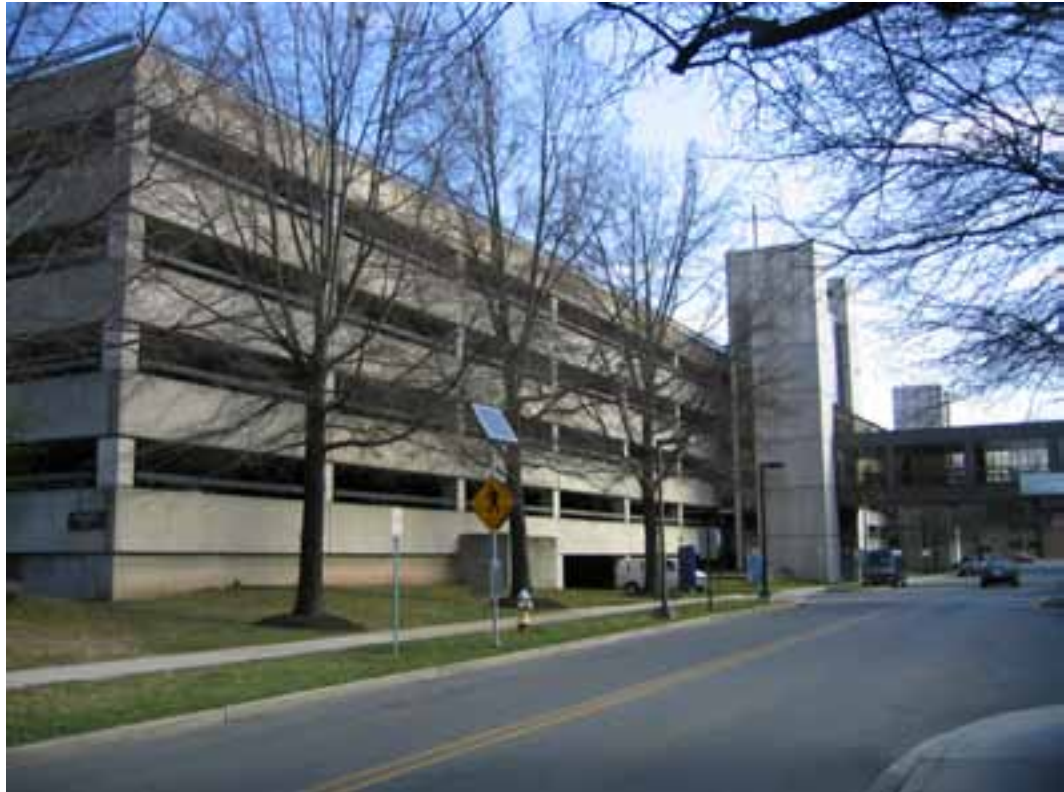
## **Building 54 – N. Garage / Warehouse / Admin.**

**Interior B (Good)** – The interior of Building 54 is in good condition. No significant cracking was noted in the parking areas. Finishes in the business areas are also in good condition.

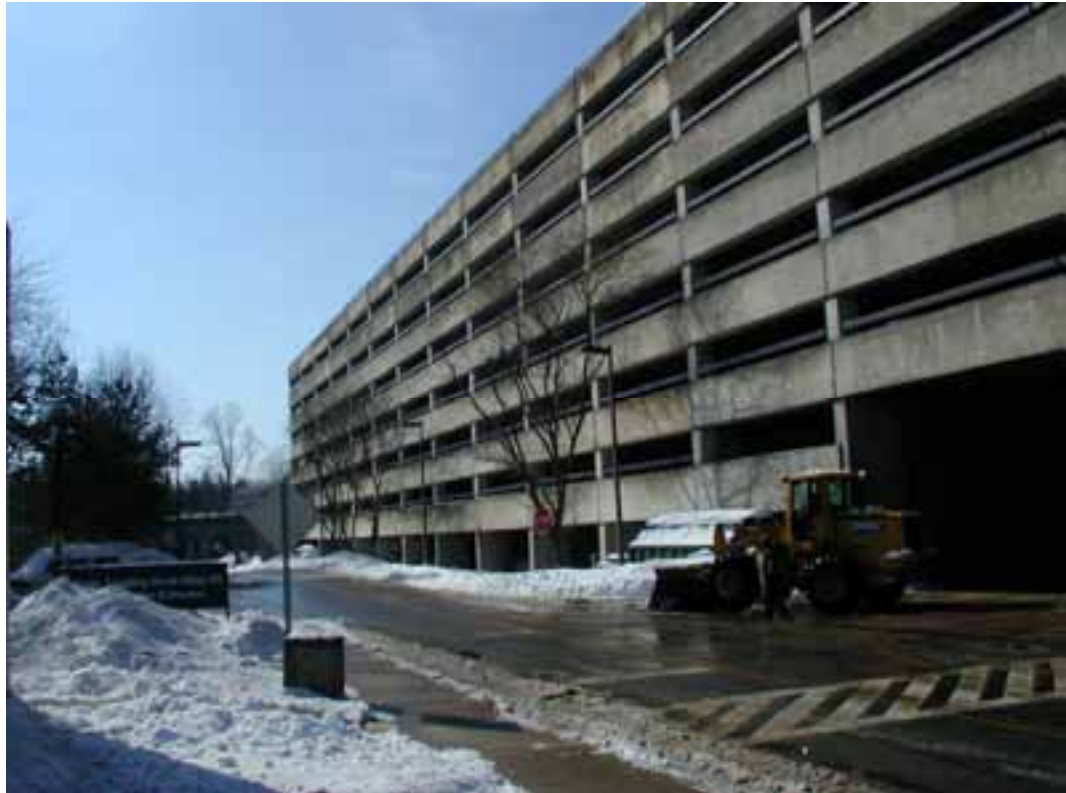
## Building 55 – S. Garage / Generators / Warehouse

**Interior C (Fair)** – The interior of Building 55 is in fair condition. No significant cracking was noted in the parking areas. Finishes in the business areas are also in fair condition.

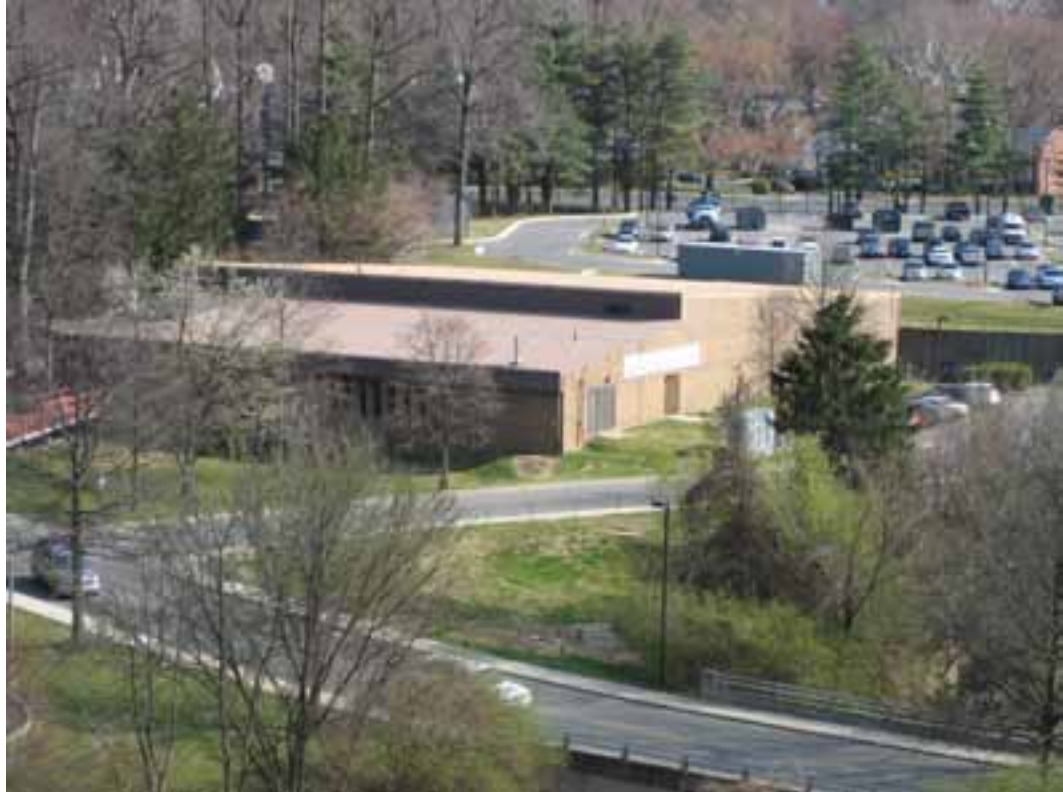
## Building 56 – Bowling Alley

**Interior B (Good)** – The interior of Building 56 is in good condition although the finishes are dated.

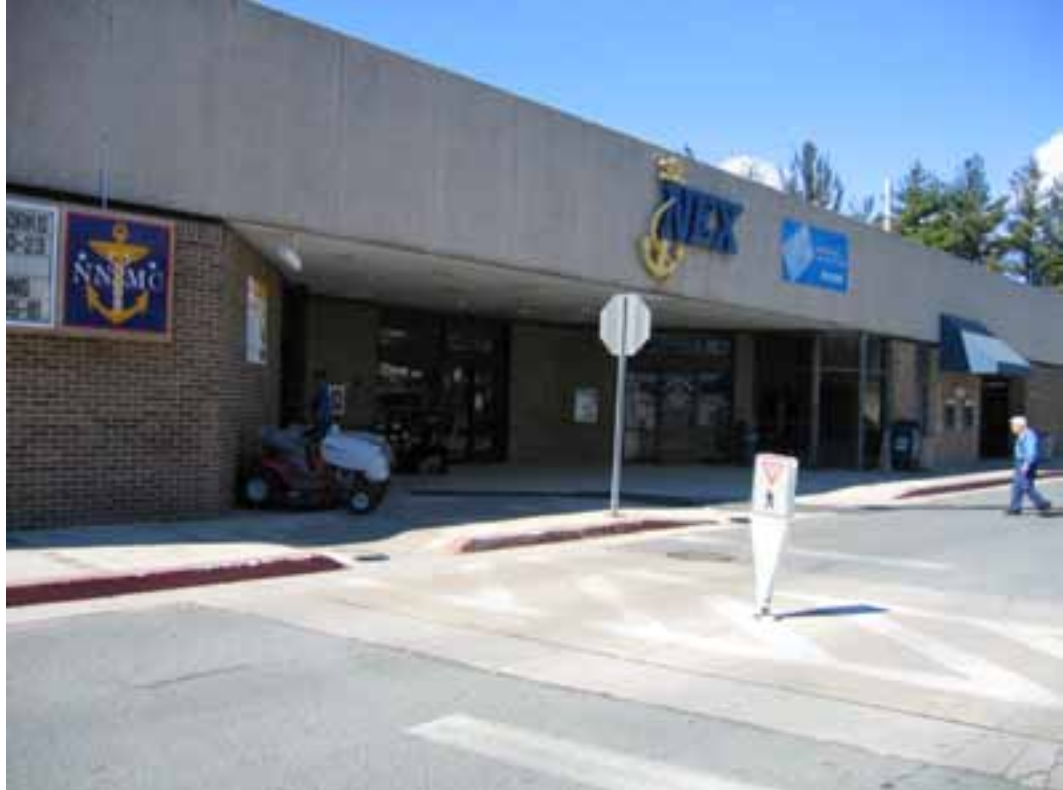
## Building 57 – NEX

**Interior C (Fair)** – The interior of Building 57 is in relatively fair condition as the finishes are somewhat worn from the heavy use of the building function. Upgrading would require not only refurbishment of the finishes, but also renovation of the toilets to comply with ADA requirements.

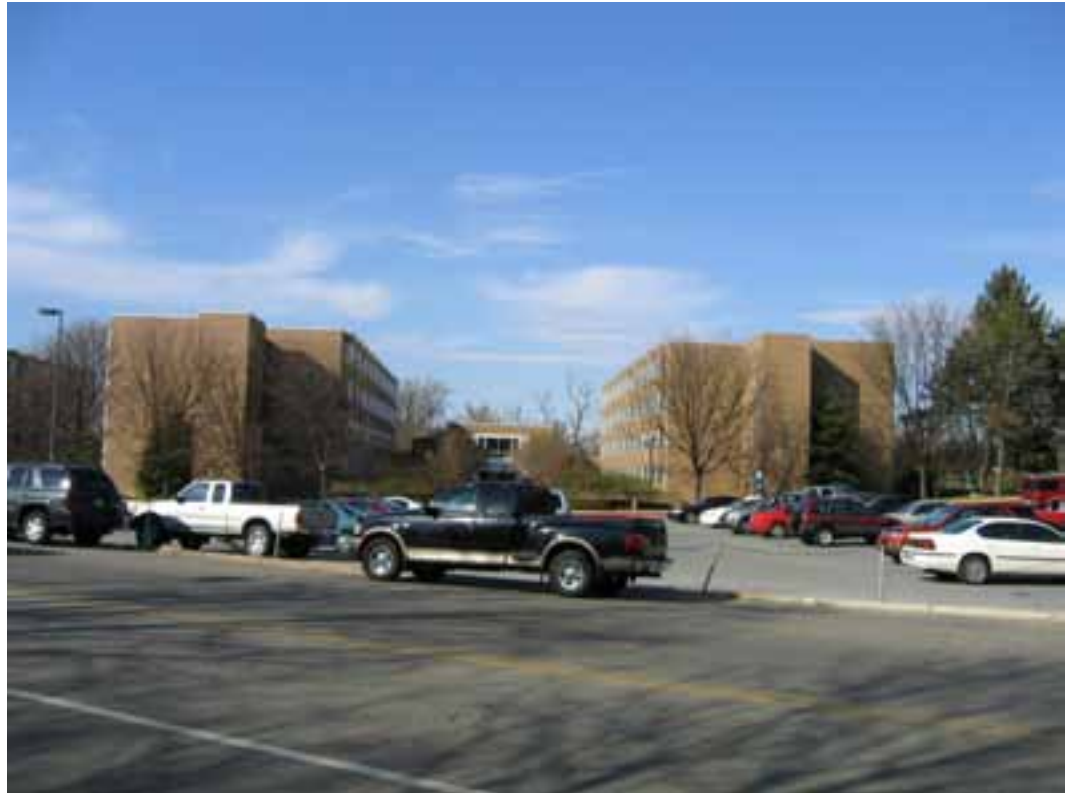
## Building 60 – E. M. Bachelors Quarters

**Interior B (Good)** – The interior of Building 60 is in relatively good condition as the finishes are somewhat worn from the heavy use of the building function. Upgrading would require not only refurbishment of the finishes but also renovation of the toilets as well as a certain percentage of the residential rooms and other minor modifications should be done for Building 60 to comply with ADA requirements.

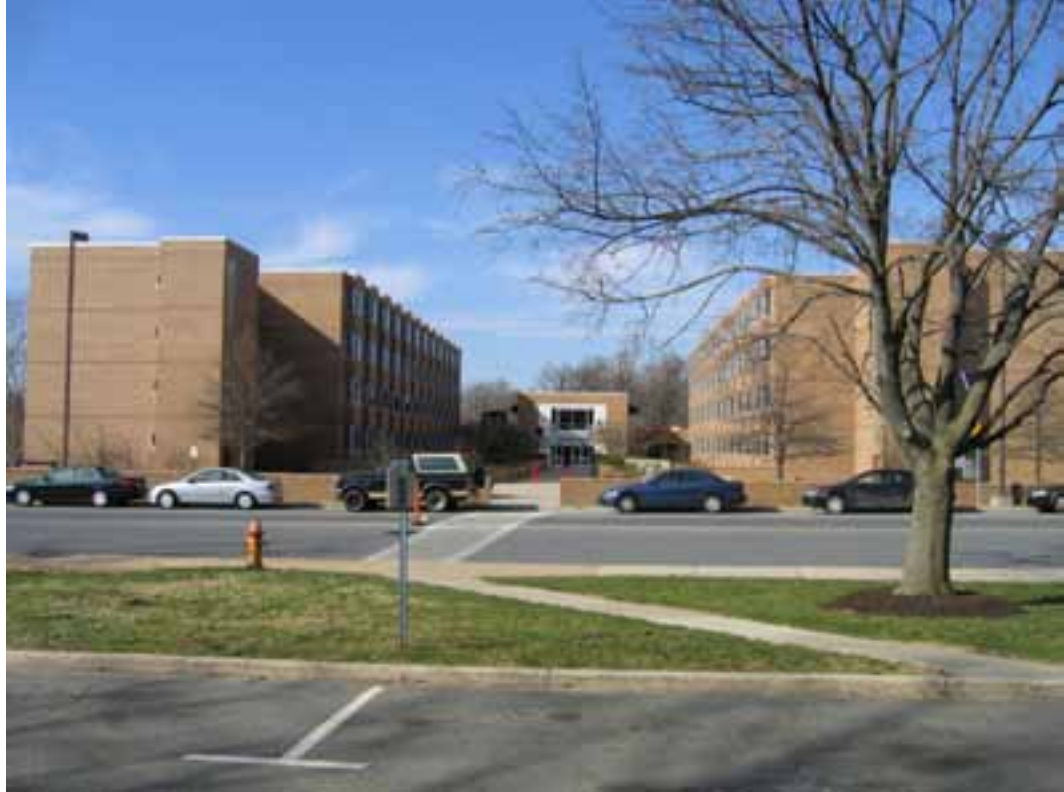
## Building 61 – E. M. Bachelors Quarters

**Interior B (Good)** – The interior of Building 61 is in relatively good condition as the finishes are somewhat worn from the heavy use of the building function. Upgrading would require not only refurbishment of the finishes but also renovation of the toilets as well as a certain percentage of the residential rooms and other minor modifications should be done for Building 61 to comply with ADA requirements.

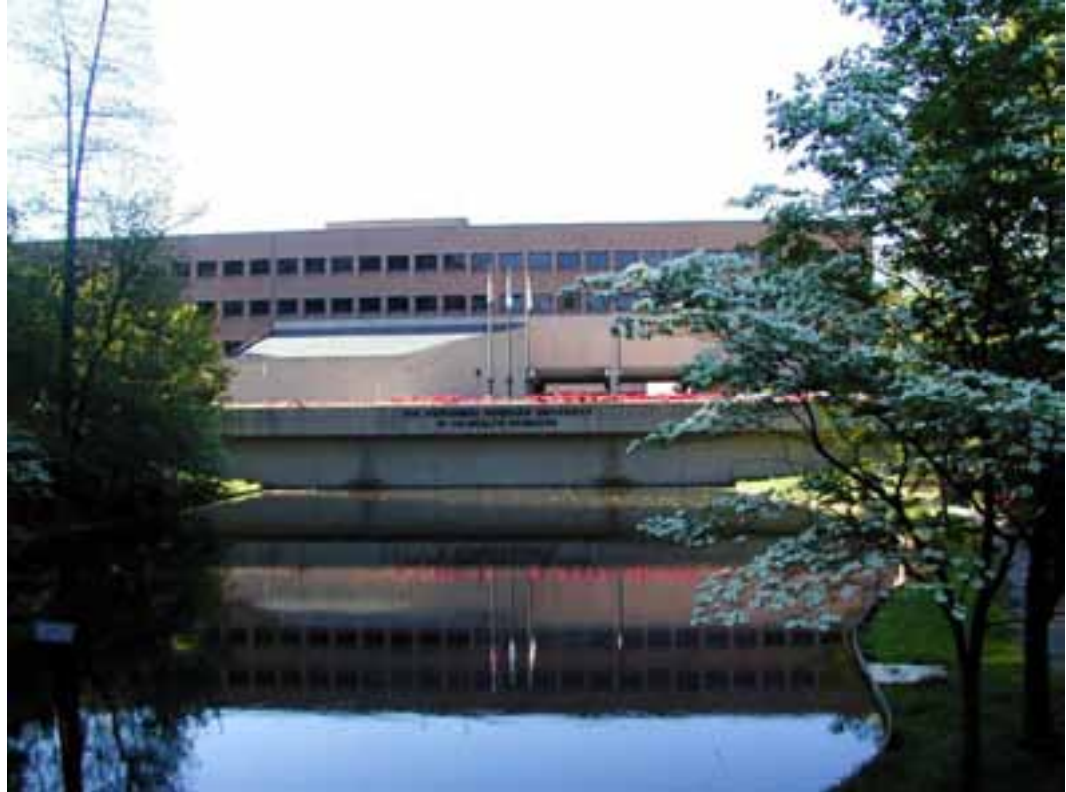
## Building 70A, 72B, 73C, 73D – USUHS

**Interior B (Good)** – The interior of Buildings 70A, 71B, 72C, and 73D are overall in good condition but not all of the building restrooms and some handrails totally comply with ADA requirements.

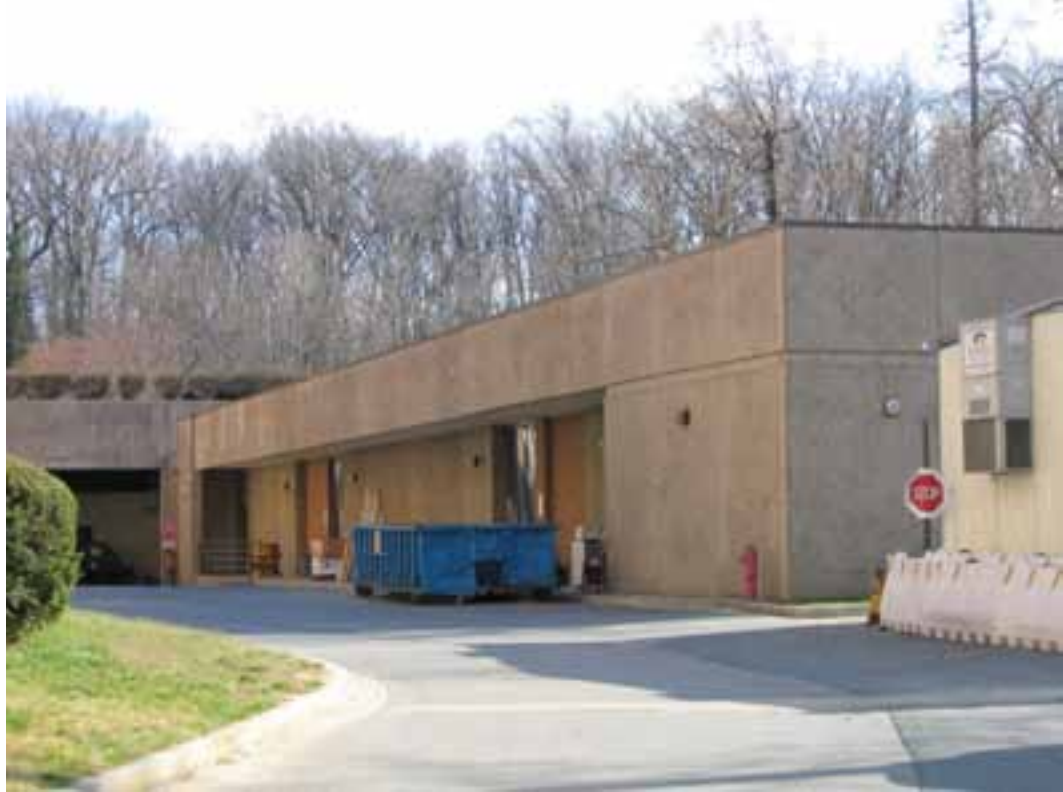
## Building 74 – Storage Facility (USUHS)

**Interior B (Good)** –The interior of Building 74 is in fair shape and has received much use. Building 74 may be too small to adequately support the USUHS complex as the archival storage has expanded into a pre-manufactured trailer immediately adjacent to and northwest of Building 74 that not indicated on the campus master plan.

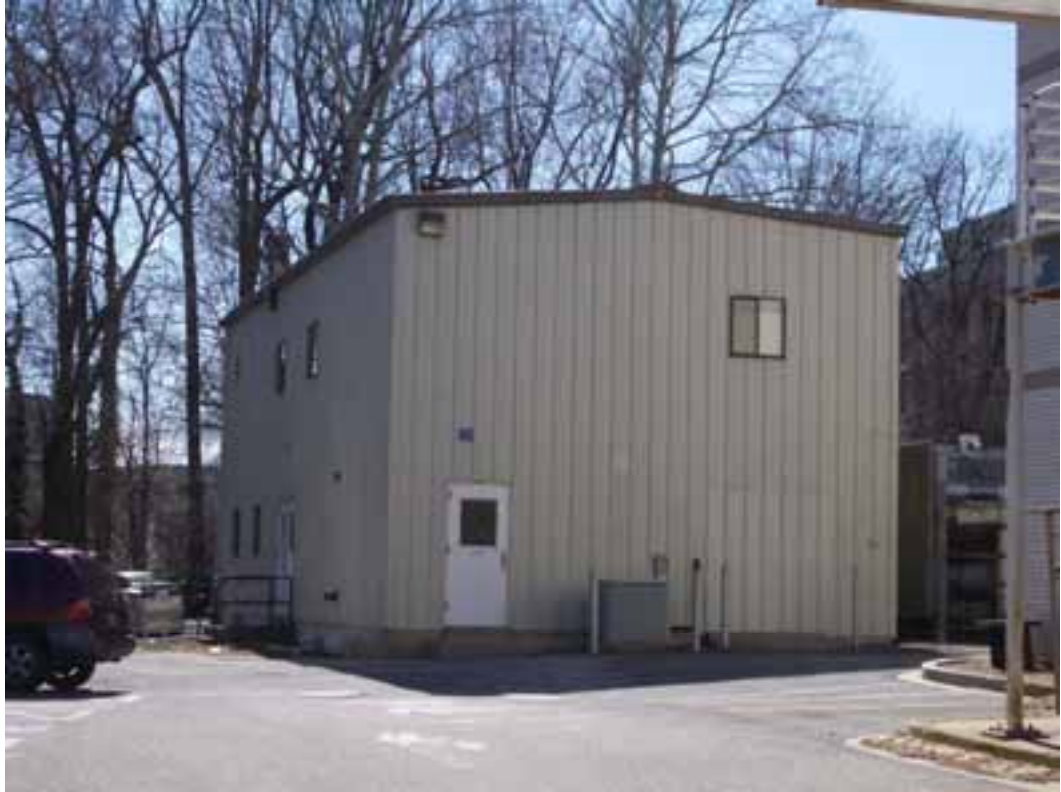
## Building 79 – Clean Room Facility (USUHS)

**Interior B (Good)** – The interior of Building 79 is in a variety of conditions with the first floor open and a second floor just recently added inside the building. To upgrade the building would require new partitions as well as finishes and may, as the building was not accessible, also require the addition of handicap toilets, and handicap accessible vertical circulation if the building is deemed to be accessible to the public.

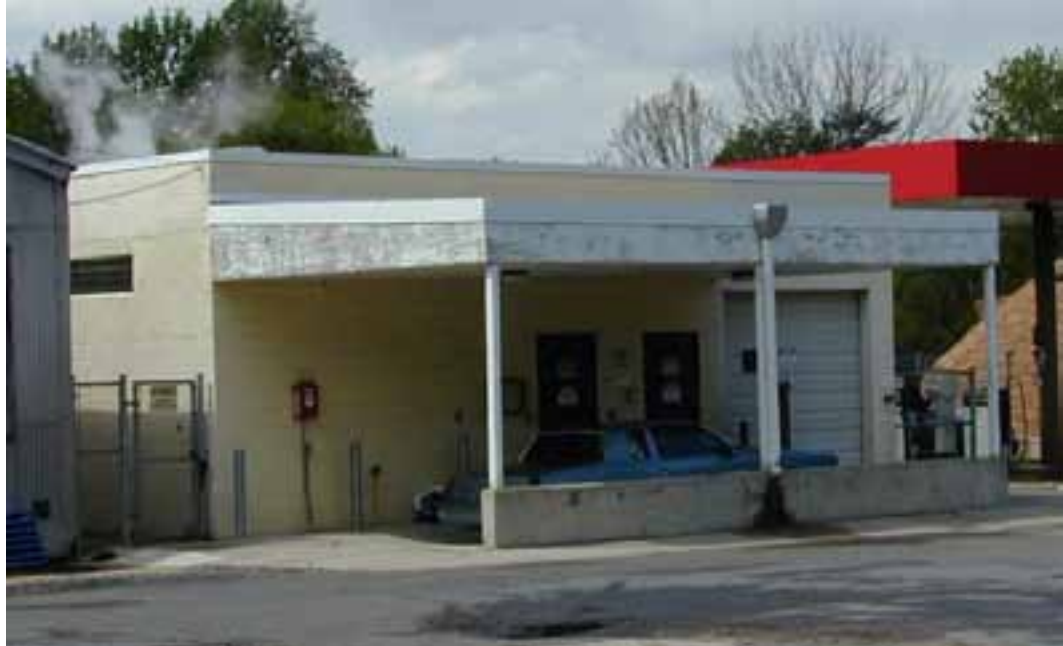
## Building 80 – Pest Control Building

**Interior C (Fair)** – Unknown; not reviewed because building was secured.

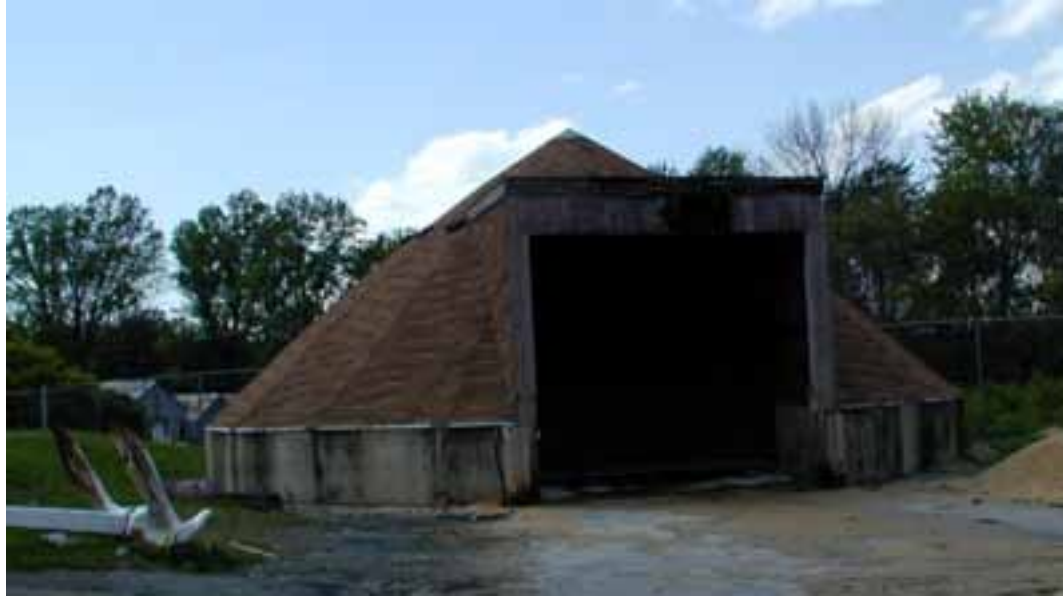
## Building 101 – Salt Storage (NAVSUPACTWASH)

**Interior D (Poor)** – The interior of Building 101 is in poor condition because the structural framing consists of unfinished wood studs continually exposed to the elements since there is no exterior door on the building.

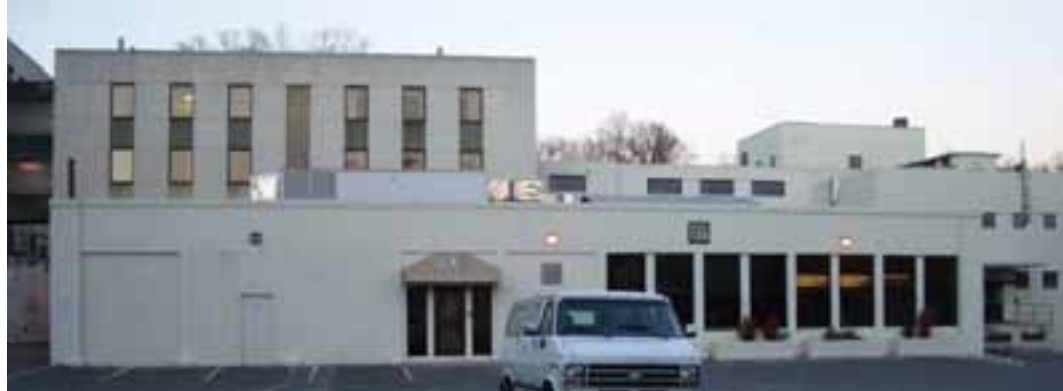
## Building 139 – Research Center

**Interior B (Good)** – The interior of Building 139 is in good condition. The original animal research laboratory was renovated into a research laboratory. Many of the finishes in the animal cage area has remained and over time held up well.

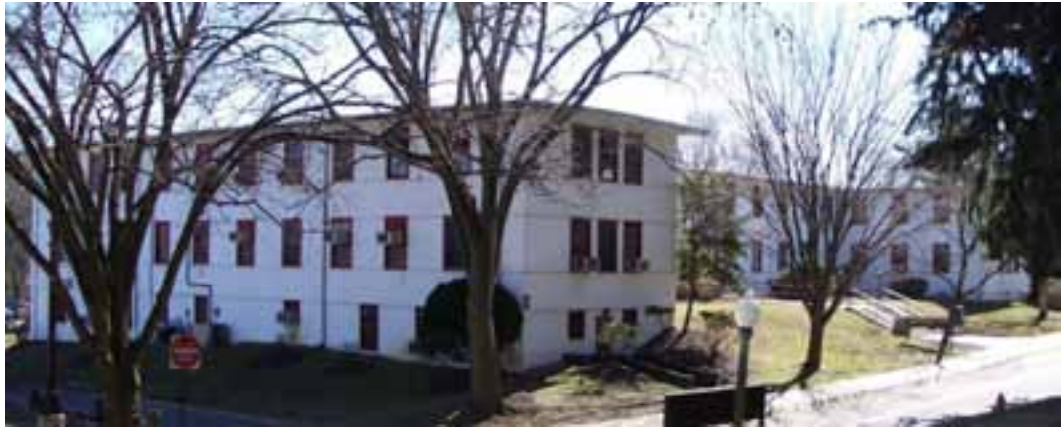
## Building 141 – Training Center (NMETC)

**Interior D (Poor)** – The interior of Building 141 is in poor condition as it visually does not appear to have been recently renovated. Some spaces remain vacant and these spaces are in disrepair as they have not been renovated. The condition of the structure is aging and may be deficient as field review noted supplemental shoring supporting the floor structure for classrooms above. Part of the basement is also not accessible as the presence of asbestos prevents occupation of some areas. Building 141 also contains hazardous spaces not properly protected with fire rated partitions and partitions with combustible finishes.

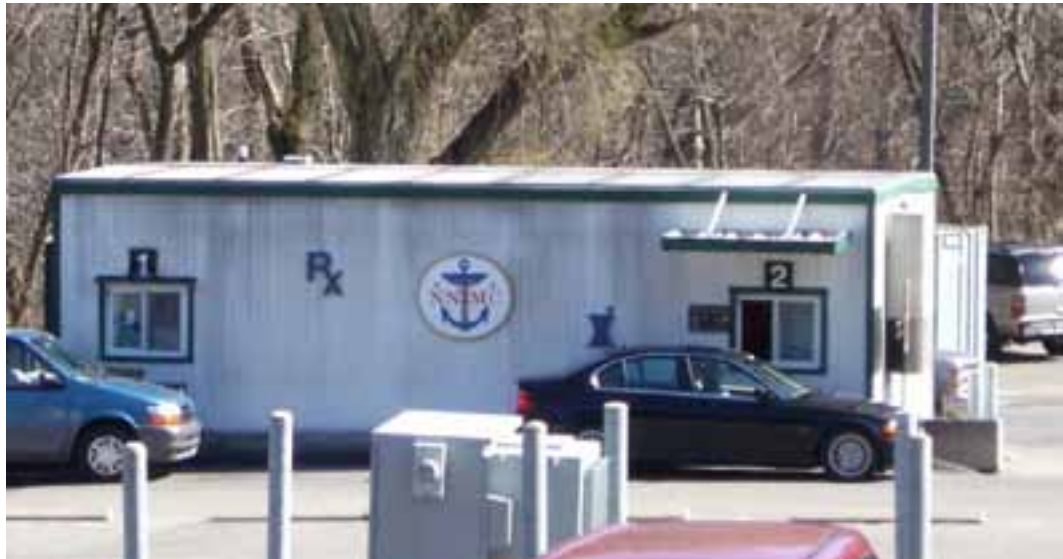
## Building 142 – Satellite Pharmacy

**Interior C (Fair)** – Building 142 which is a pre-manufactured mobile trailer currently set up to function as a pharmacy is flexible and could easily be revised or relocated to serve other designated functions but not easily be expanded.

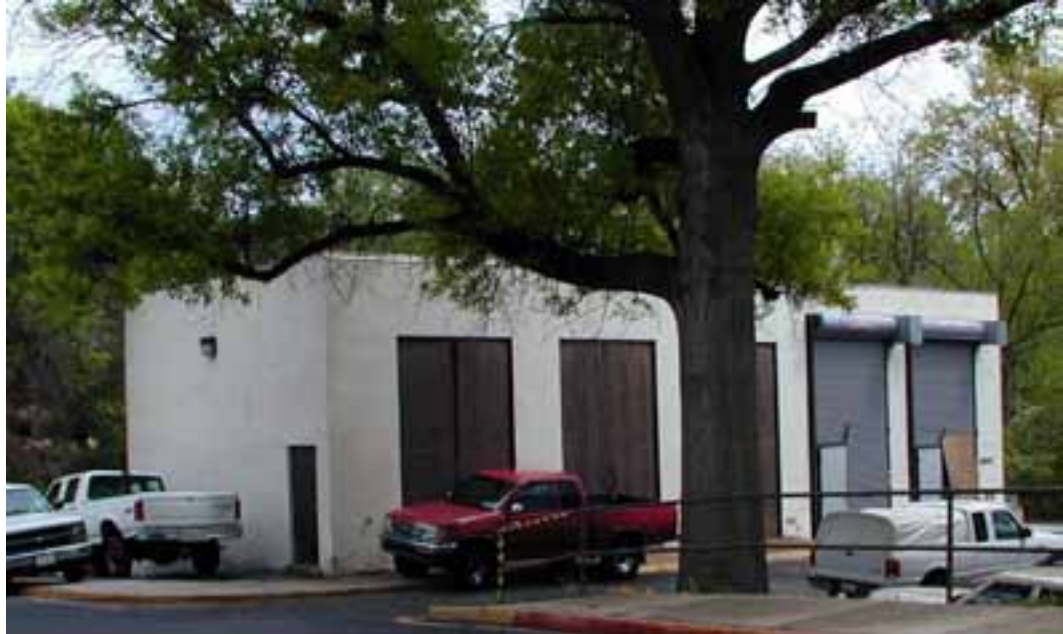
## Building 143 – Shops

**Interior D (Poor)** – The interior of Building 143 is in poor condition as the original part of the building is old and reaching its life expectancy. This portion is filled with stored materials so much so that it is difficult to access some of the materials. The newer section of the building is overall in good condition except for a few egress life safety code violations including the lighting and stairs.

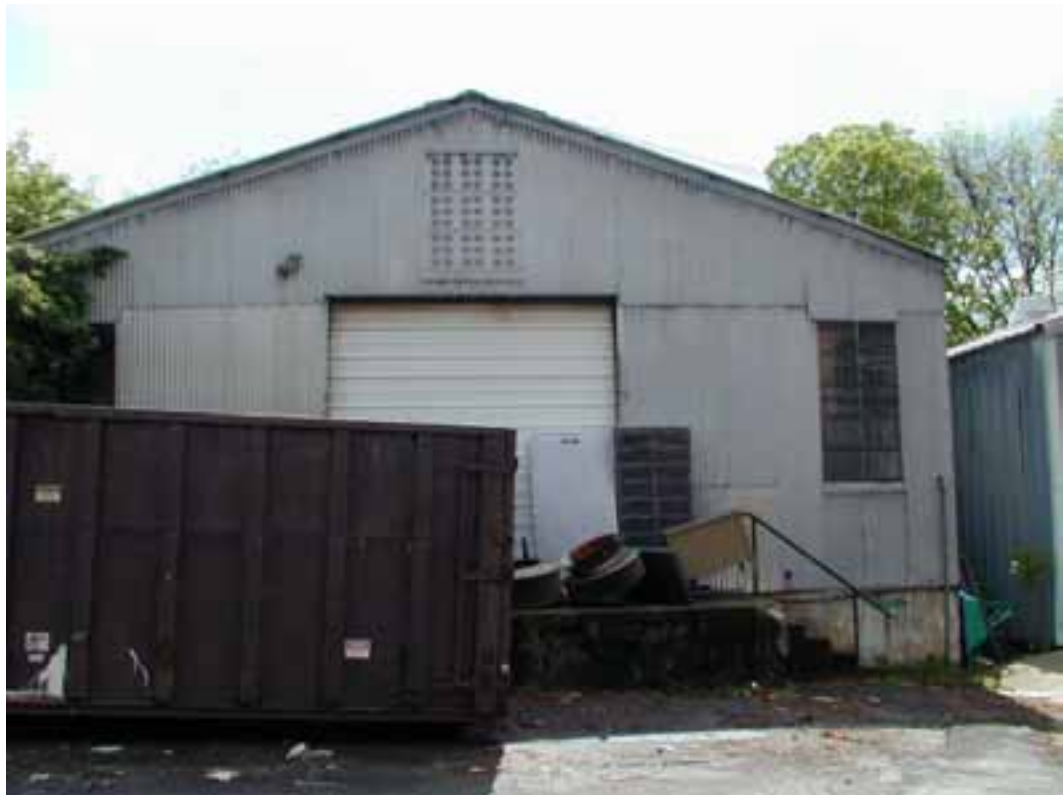
## Building 147 - Building 239 – General Warehouses

Remainder of Buildings 203, 225, and 239 are in fair condition as they are not as old as the original warehouses.

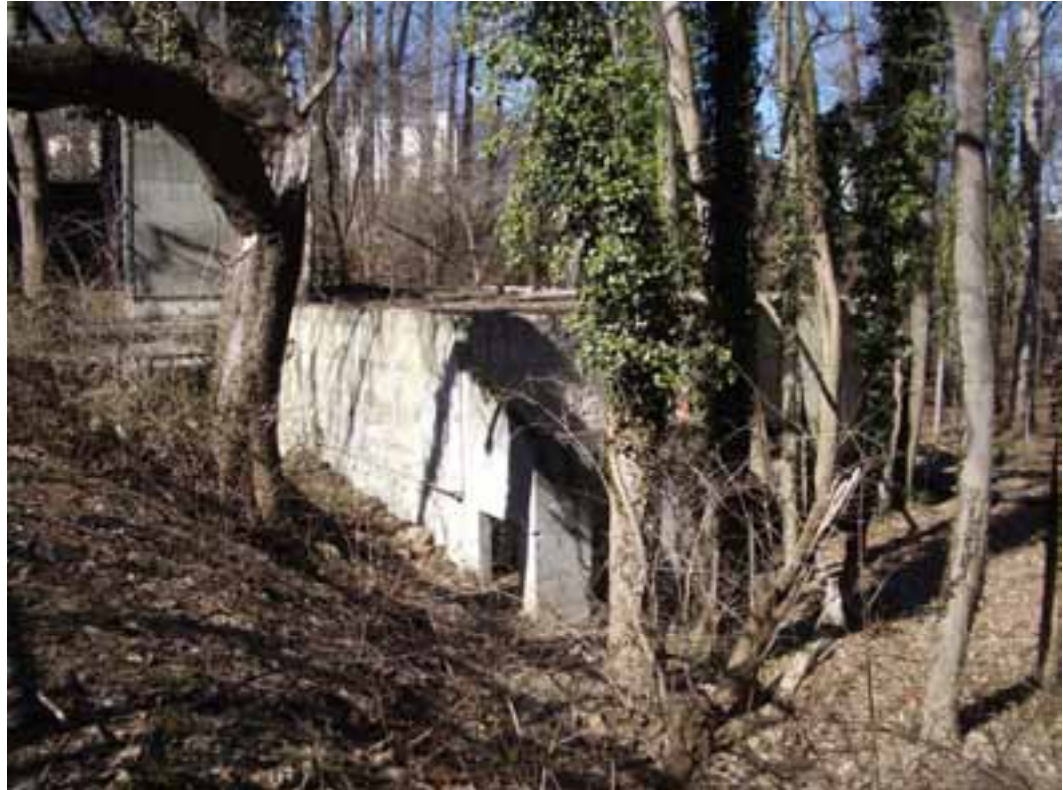
## Building 150 – Abandoned

**Interior E (Unacceptable)** – The interior of Building 150 is in a similar unacceptable condition as the exterior because it is open to the environment since the doors to the building have long ago deteriorated and rotted away. Paint is peeling from the walls and there is a large amount of organic debris found inside the building. Similar to the elevator hoistway the remainder of the Building 150 has become obsolete since the research facility was abandoned and therefore should be demolished.

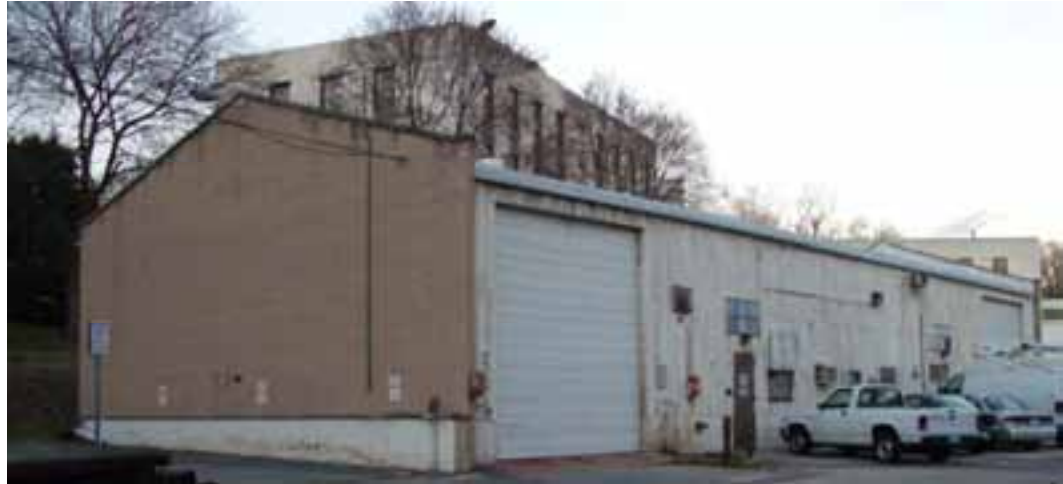
## Building 155 – Vehicle Maintenance

**Interior D (Poor)** – Not reviewed. Building was secured.

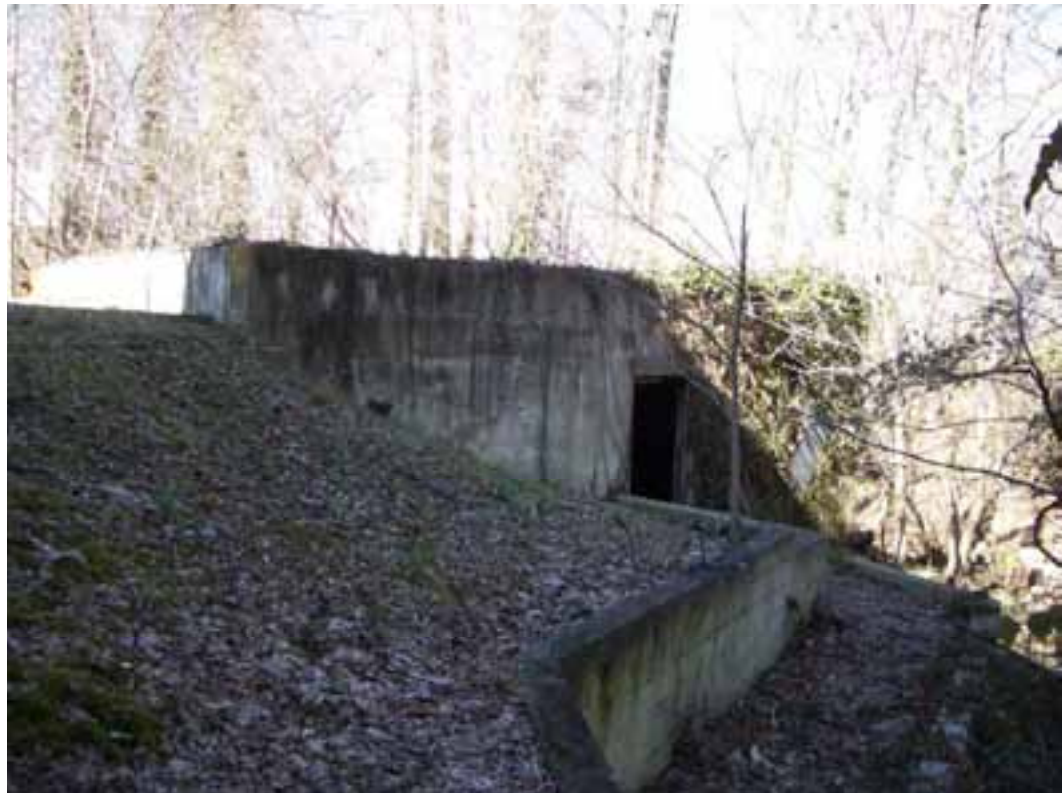
## Building 176 – Abandoned

**Interior E (Unacceptable)** – The interior of Building 176 is in poor condition and similar to the exterior has areas of peeling paint. The only door into the building is missing leaving the building exposed and open to the elements therefore debris has built up inside of the building.

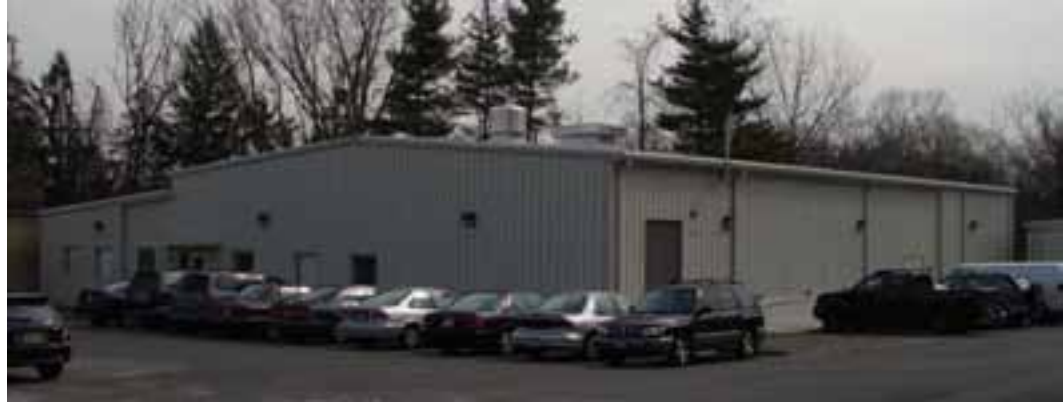
## Building 241 – Blood Bank (NNMC)

**Interior B (Good)** – The interior of Building 241 is in good condition based on the 2003 renovation.

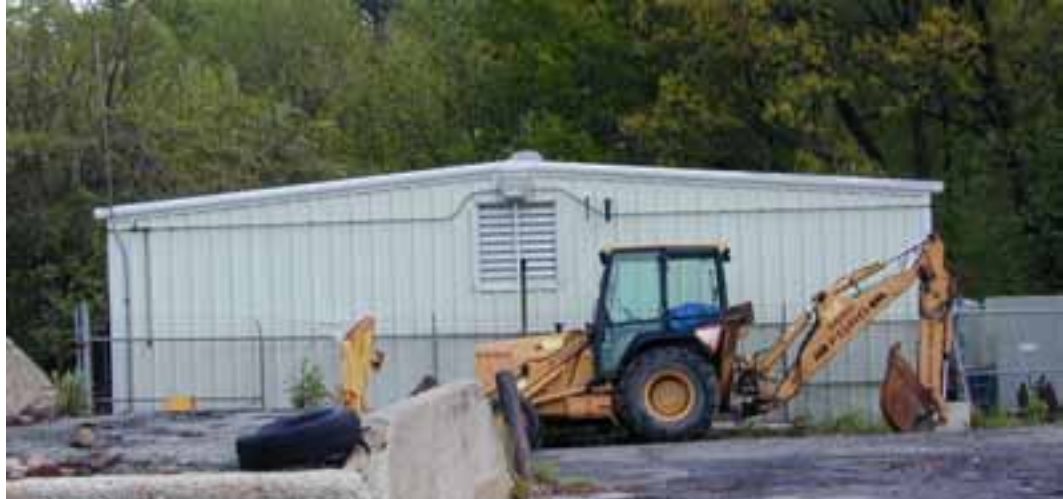
## Building 242 – General Warehouse

**Interior U (Unknown)** – Not reviewed. Building was secured.

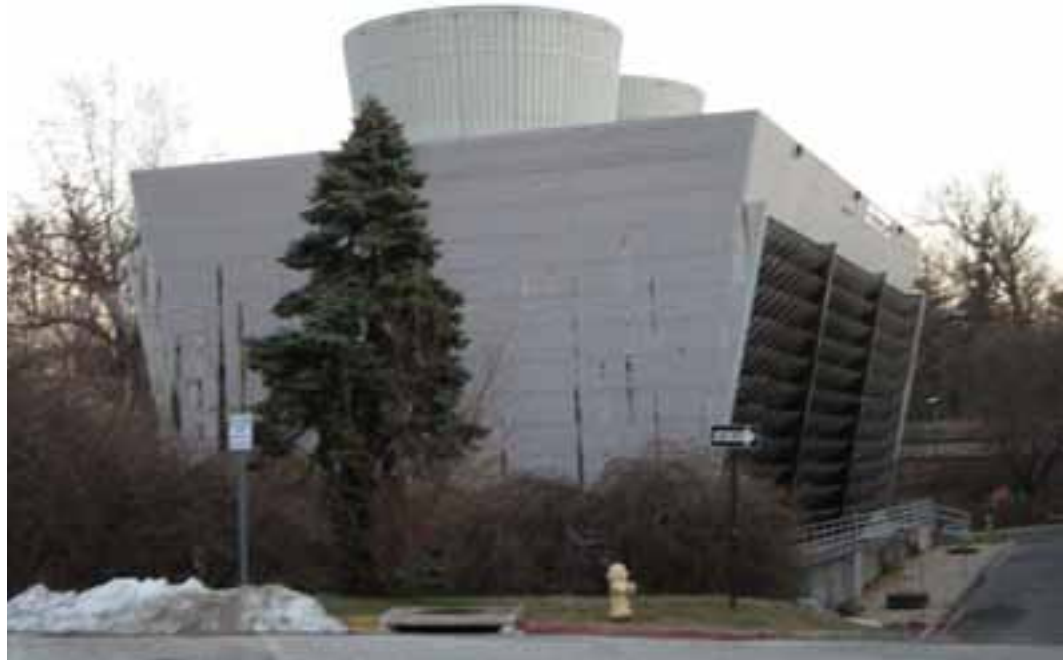
## Building 252 – Cooling Tower

**Interior U (Unknown)** – The interior of Building 252 includes a lot of equipment in different stages of its life expectancy. Much of the equipment looks to be the original equipment. Overall the interior seems to be in a condition of normal wear and tear commensurate with this type of structure.
